**ANALYSIS REPORT FOR
STRUCTURAL RESTORATION
AT
LIFE INSURANCE CORPORATION BUILDING
PARAMAKUDI**

ANALYSIS:

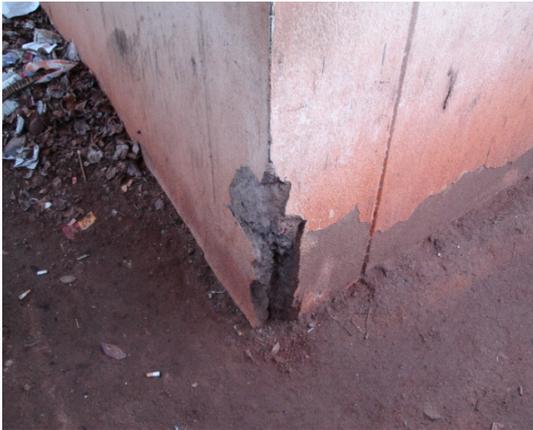
- ❖ The bonding between the plastering and RCC columns are weak as shown in the picture. It is due to the corrosion of the rebar.

- ❖ Dismantling debonded areas, cleaning the debris up to a lead of 50mts.
- ❖ Cleaning the ceiling surface to be free of dust and loose particles.
- ❖ Cleaning the rebar's to be free of rusted scales and providing one coat of **TEC^R BEAT ZR** and allowing to dry.
- ❖ Wetting the chipped of surface and providing one bond coat of **TEC^R BOND SBR SUPER**.
- ❖ Pour **TEC^R GROUT MC** after providing proper shuttering.

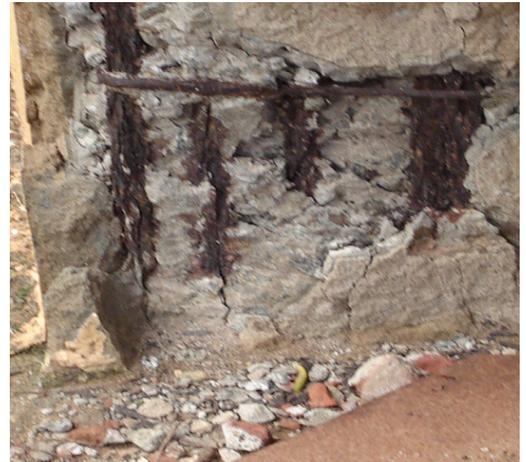
- ❖ In many areas the spalling in the columns are visible where major portion of the rods has been rusted. A closer view of the column is shown in the adjacent picture.

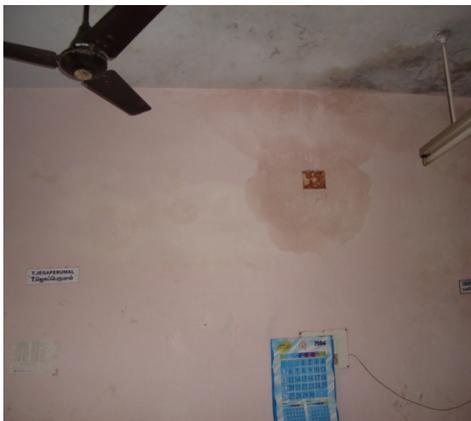
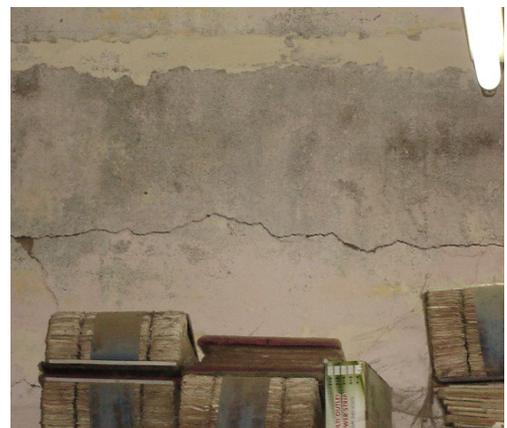
- ❖ Dampness has been identified from various places due to the cracks found near beams and brick work joints.

The pictures show the dampness in the walls and ceiling areas. The cracks near the beam area are also clearly visible.

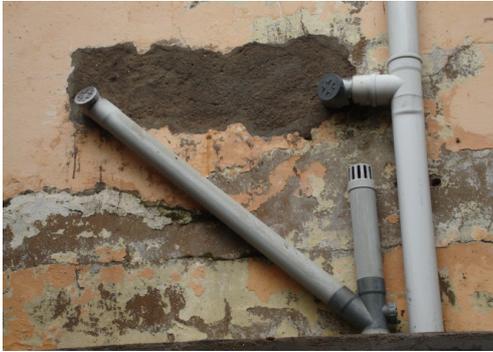
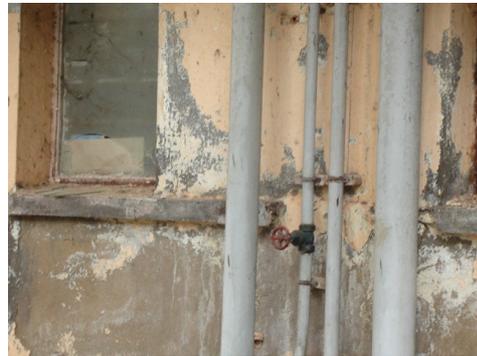
- ❖ Dampness is found in the rear because of water seepage from outlet pipes provided from the toilet.

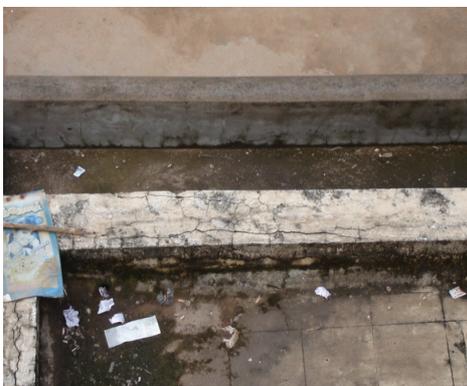
- ❖ In many places cracks are visibly seen inside and outside the building.

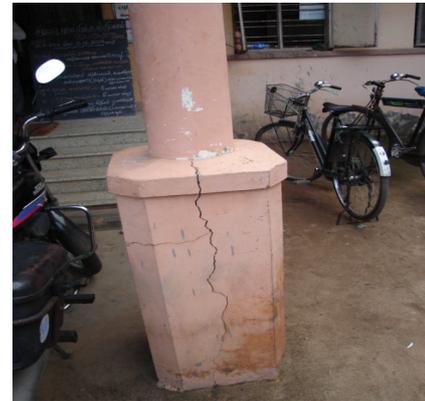
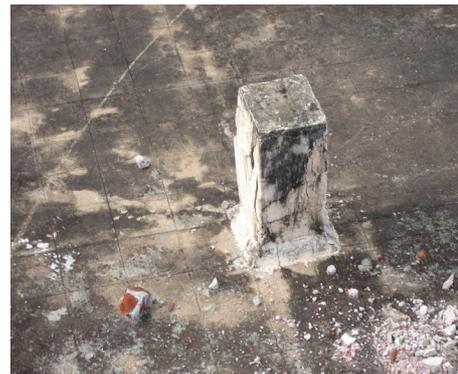
the roof slabs and inverted beams in the roof.

- ❖ Water leakages are found in many places due to the cracks in

- ❖ Dismantling the existing mortar toppings to expose the virgin concrete surface. Cleaning the surface to be free of dust, loose particles and atmospheric deposits.

- ❖ The concrete surface shall be wetted thoroughly and ensuring that there is no water puddle. Two coats of **TEC^R WAVE 2000** – Water proofing membrane coating shall be provided by brush, as per the application specifications. (The product literature is enclosed)
