**TECHNY
CHEMY**

**ANALYSIS REPORT FOR REPAIRS AT
SPICE BOARD BUILDING - TUTICORIN**

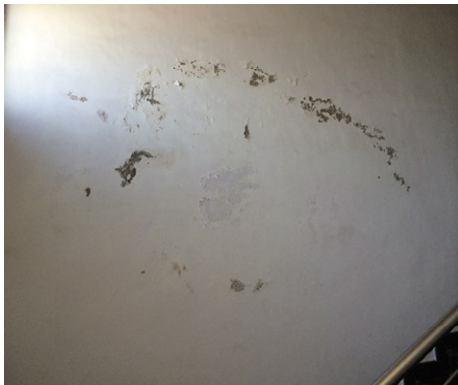
- ❖ Dampness has been identified from various places due to the cracks found near beams and brick work joints.

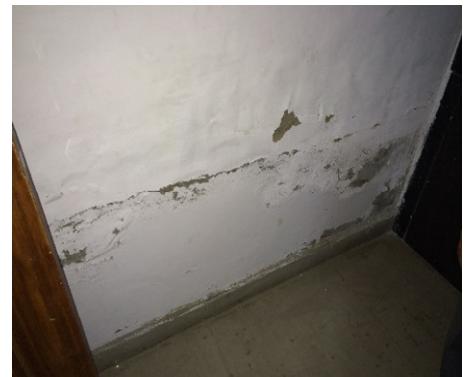
- ❖ *The pictures show the dampness in the walls and ceiling areas. The cracks near the beam area are also clearly visible.*

(d) CRACK FILLING FOR BEAM & BW JOINTS and COLUMN & BW JOINTS:

- ❖ Cut a groove along the crack to widen it to absorb the material.
- ❖ The surface shall be cleaned with water wash.
- ❖ The cracks shall be applied with the bond coat of **TEC^R BOND SBR SUPER** in the ratio of 1:1:1 (Cement: TEC^R BOND SBR SUPER: WATER)
- ❖ Mix **TEC^R KRACK FILLER** as per the mix specification and fill it thoroughly and any excess material protruding beyond the plastering may be removed with a squeeze or float.

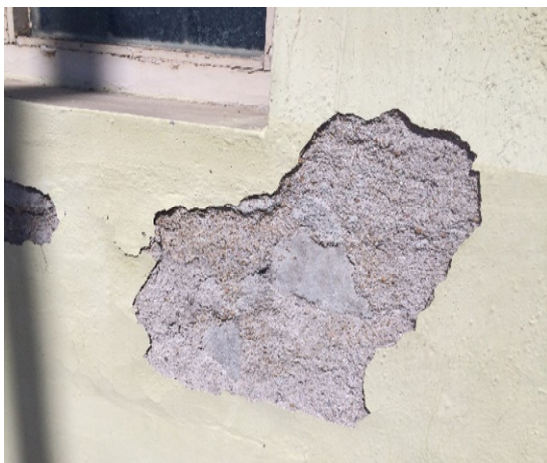
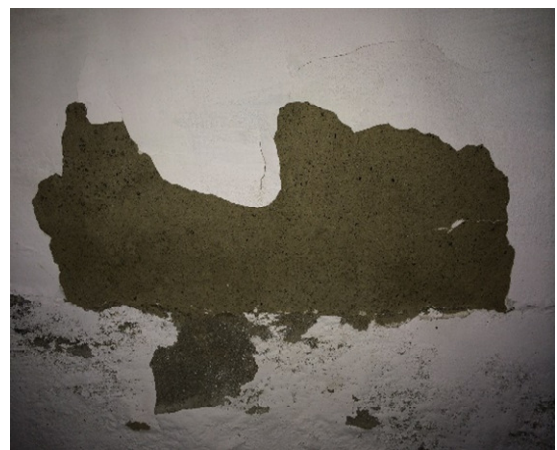
- ❖ Dampness is found in the rear because of water seepage from outlet pipes provided from the toilet.
- ❖ In lot of places spalling can be seen in the plastering. It might be due to the mix proportion. On checking only traces of cement was found. Another reason might be use of salty sand.

(b) SPALLING RECTIFICATIONS FOR WALL PLASTERING:

- ❖ Chip the areas where damages and seepages are found in the external and internal walls.
- ❖ Clean the surface to be free of dust and loose particles and give a water wash to remove the salt contamination.
- ❖ Wet the chipped of surface and providing one bond coat of **TEC^R BOND SBR SUPER** in the ratio of 1:1:1 (Cement: TEC^R BOND SBR SUPER: WATER)
- ❖ While the bond coat is still tacky, Re-plastering in CM 1:4 admixed with **TEC^R POROSEAL** at the ratio of 500 gms per bag of cement should be carried out and finished with wooden float.
- ❖ The entire external wall may be coated with **TEC^R WAVE DP** to prevent dampness from external forces.

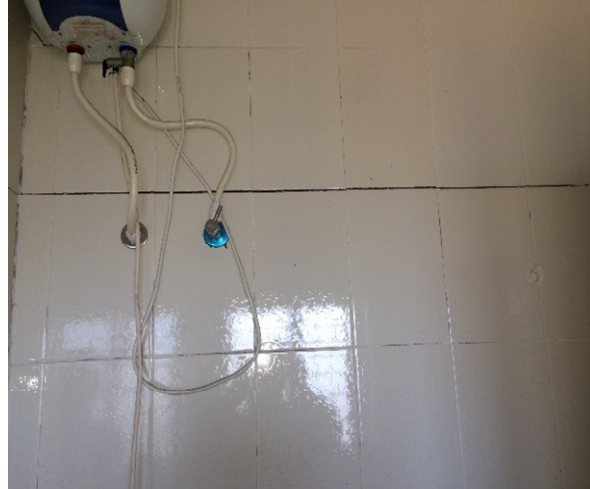
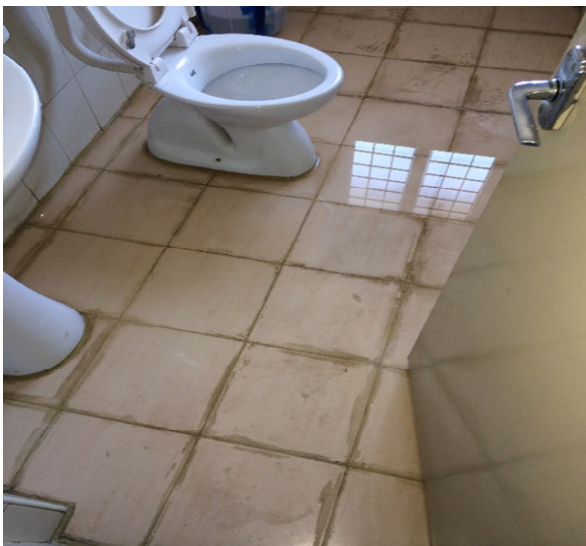
- ❖ In many places cracks are visibly seen inside and outside the building. Almost all the inner walls of 4.5" thickness are having cracks.
- ❖ Dampness is found in the walls of third floor guest room 2 which is because of the water stagnant in the toilet and the slope is improper. Further cracks can be seen in the tiles also.
- ❖ In the front portion the columns are seen to be settling, since we had not taken any test pit, this analysis is based purely on our experience and assumption as we

could find cracks near the window on both sides which is diagonally opposite which might be due to the settlement of the columns. Solutions for this problem has not be given as we had to open the side portion and check for the actual problem. For the cracks we had adopted stitching procedure which might solve the problem to a certain extent.

(d) CRACK FILLING IN 4.5” WALLS:

- ❖ Cut a groove along the crack to widen it to absorb the material.
- ❖ The surface shall be cleaned with water wash.
- ❖ The cracks shall be applied with the bond coat of **TEC^R BOND SBR SUPER** in the ratio of 1:1:1 (Cement: TEC^R BOND SBR SUPER: WATER)
- ❖ Mix **TEC^R KRACK FILLER** as per the mix specification and fill it thoroughly and any excess material protruding beyond the plastering may be removed with a squeeze or float.
