**TECHNY
CHEMY**

**ANALYSIS REPORT FOR REPAIRS AT
SPICE BOARD BUILDING - TUTICORIN**

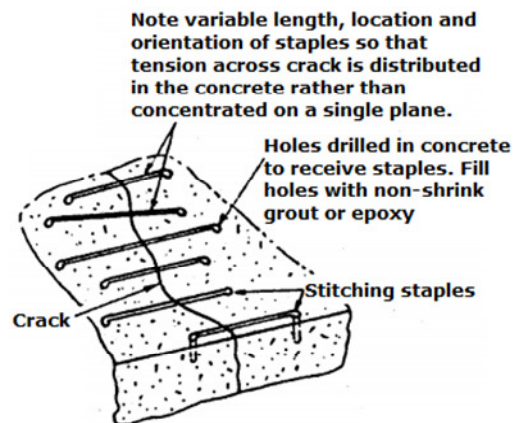
- ❖ In many places cracks are visibly seen inside and outside the building. Almost all the inner walls of 4.5" thickness are having cracks.
- ❖ Dampness is found in the walls of third floor guest room 2 which is because of the water stagnant in the toilet and the slope is improper. Further cracks can be seen in the tiles also.
- ❖ In the front portion the columns are seen to be settling, since we had not taken any test pit, this analysis is based purely on our experience and assumption as we

- ❖ Cut a groove along the crack to widen it to absorb the material.
- ❖ The surface shall be cleaned with water wash.
- ❖ The cracks shall be applied with the bond coat of **TEC^R BOND SBR SUPER** in the ratio of 1:1:1 (Cement: TEC^R BOND SBR SUPER: WATER)
- ❖ Mix **TEC^R KRACK FILLER** as per the mix specification and fill it up to the brick level and any excess material may be removed with a squeeze or float.
- ❖ 6mm rods can be bend and placed with an interval of 15cms as shown in the picture over the filled area
- ❖ Wet the surface and provide one bond coat of **TEC^R BOND SBR SUPER** in the ratio of 1:1:1 (Cement: TEC^R BOND SBR SUPER: WATER)
- ❖ While the bond coat is still tacky, Re-plastering in CM 1:4 admixed with **TEC^R POROSEAL** at the ratio of 500 gms per bag of cement should be carried out and finished with wooden float.
